**DELAWARE RIVER BASIN
TONICKON CREEK, BUCKS COUNTY**

**PENNSYLVANIA
ID NO. PA.00734**

**NOCKAMIXON STATE
PARK DAM**

**PHASE I INSPECTION REPORT
NATIONAL DAM INSPECTION PROGRAM**

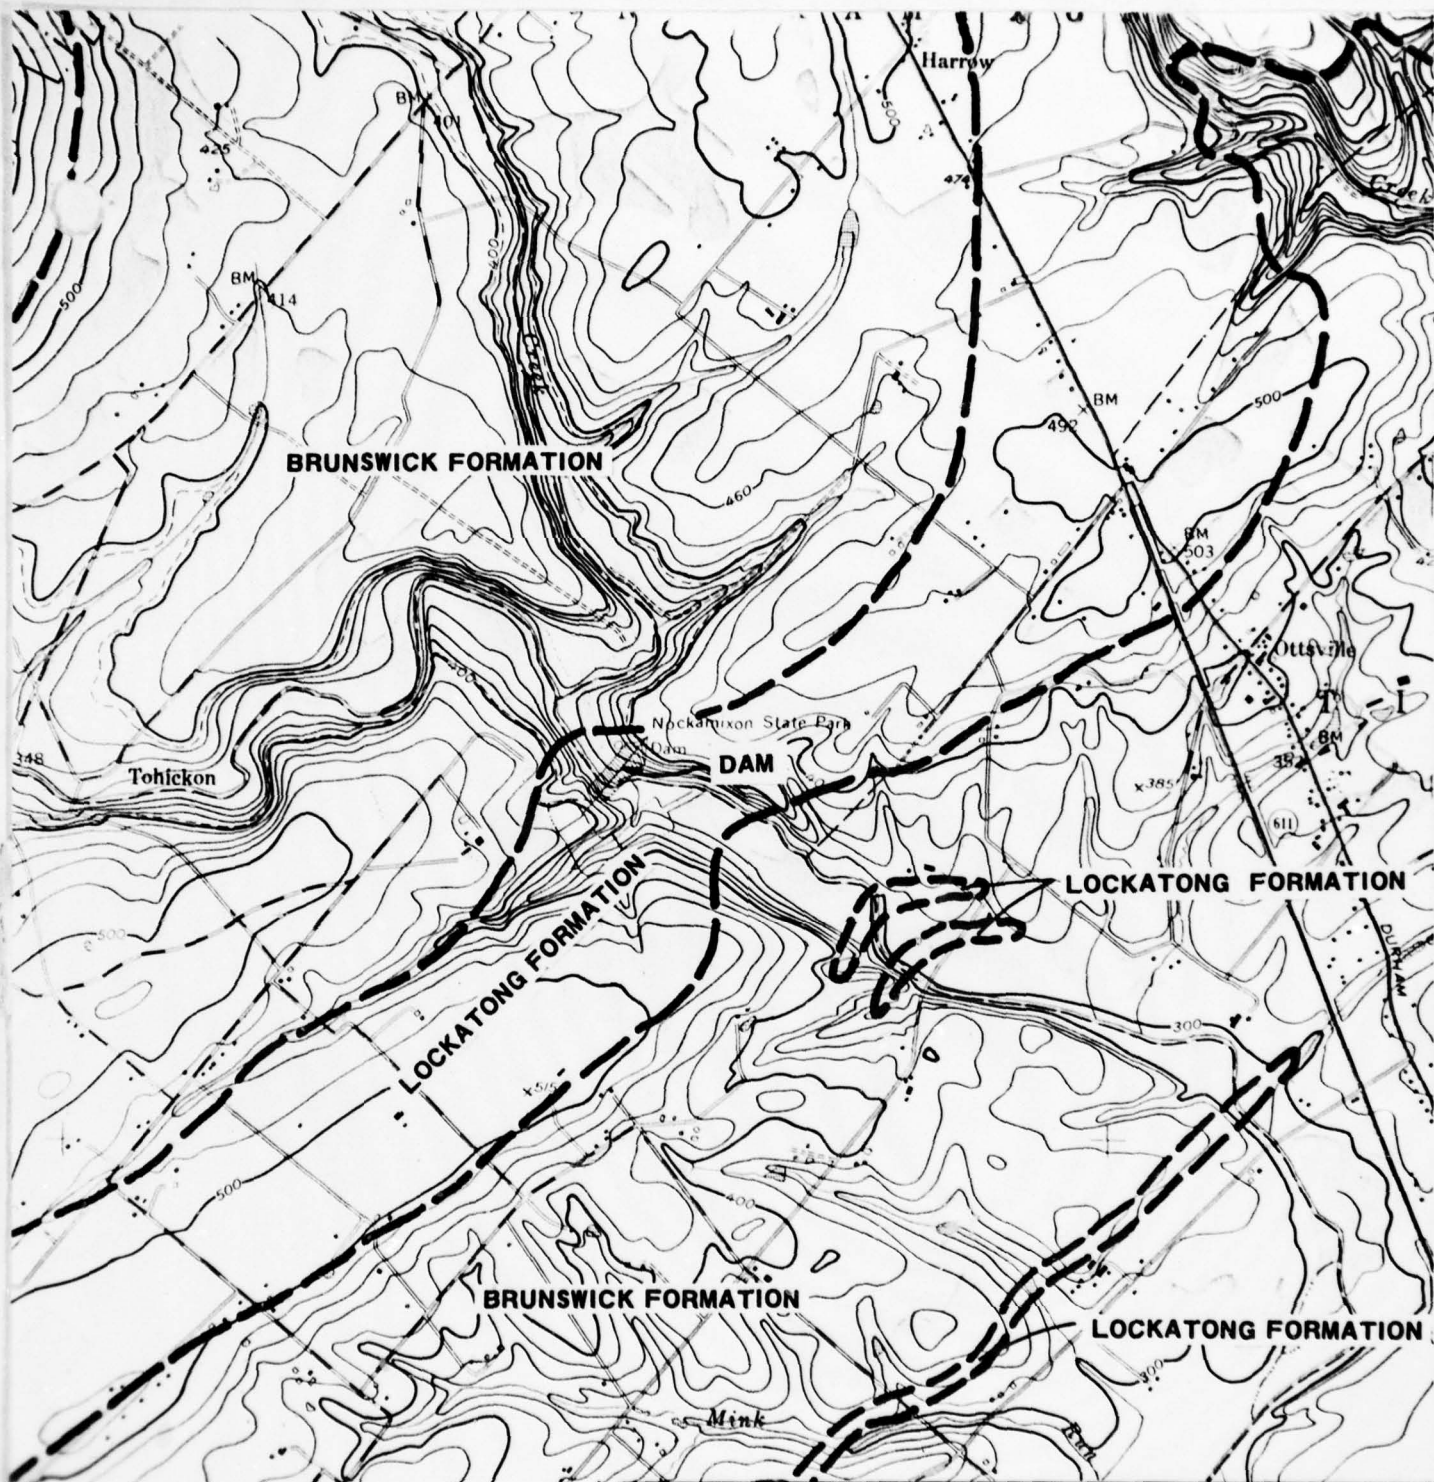
'SITE GEOLOGIC MAP		
NOCKAMIXON STATE PARK DAM		
NAT. ID NO. PA.00734		BUCKS COUNTY
DATA OBTAINED FROM PENNA. GEOLOGIC SURVEY BULLETIN C9 PLATE 2, 1950 (WILLARD, et al., 1950)		
		PLATE F-1

The bedrock in the vicinity of the dam site is shown on Plate F-1. Downstream seepage should be minimal due to the impervious nature of the rock; the bedding and jointing striking approximately parallel to the dam axis; and lack of faulting at the site.
